Re: Report on Network Level Pavement Evaluation  
City of Kirtland – 2020 Visual Pavement Evaluation  
Kirtland, Ohio  
SME Project No. 083631.00

SME has completed our visual pavement evaluation for select roads within the City of Kirtland. This report presents the results of our observations and analyses, and presents our recommendations for the rehabilitation/reconstruction of the various paved areas at the reviewed facility.

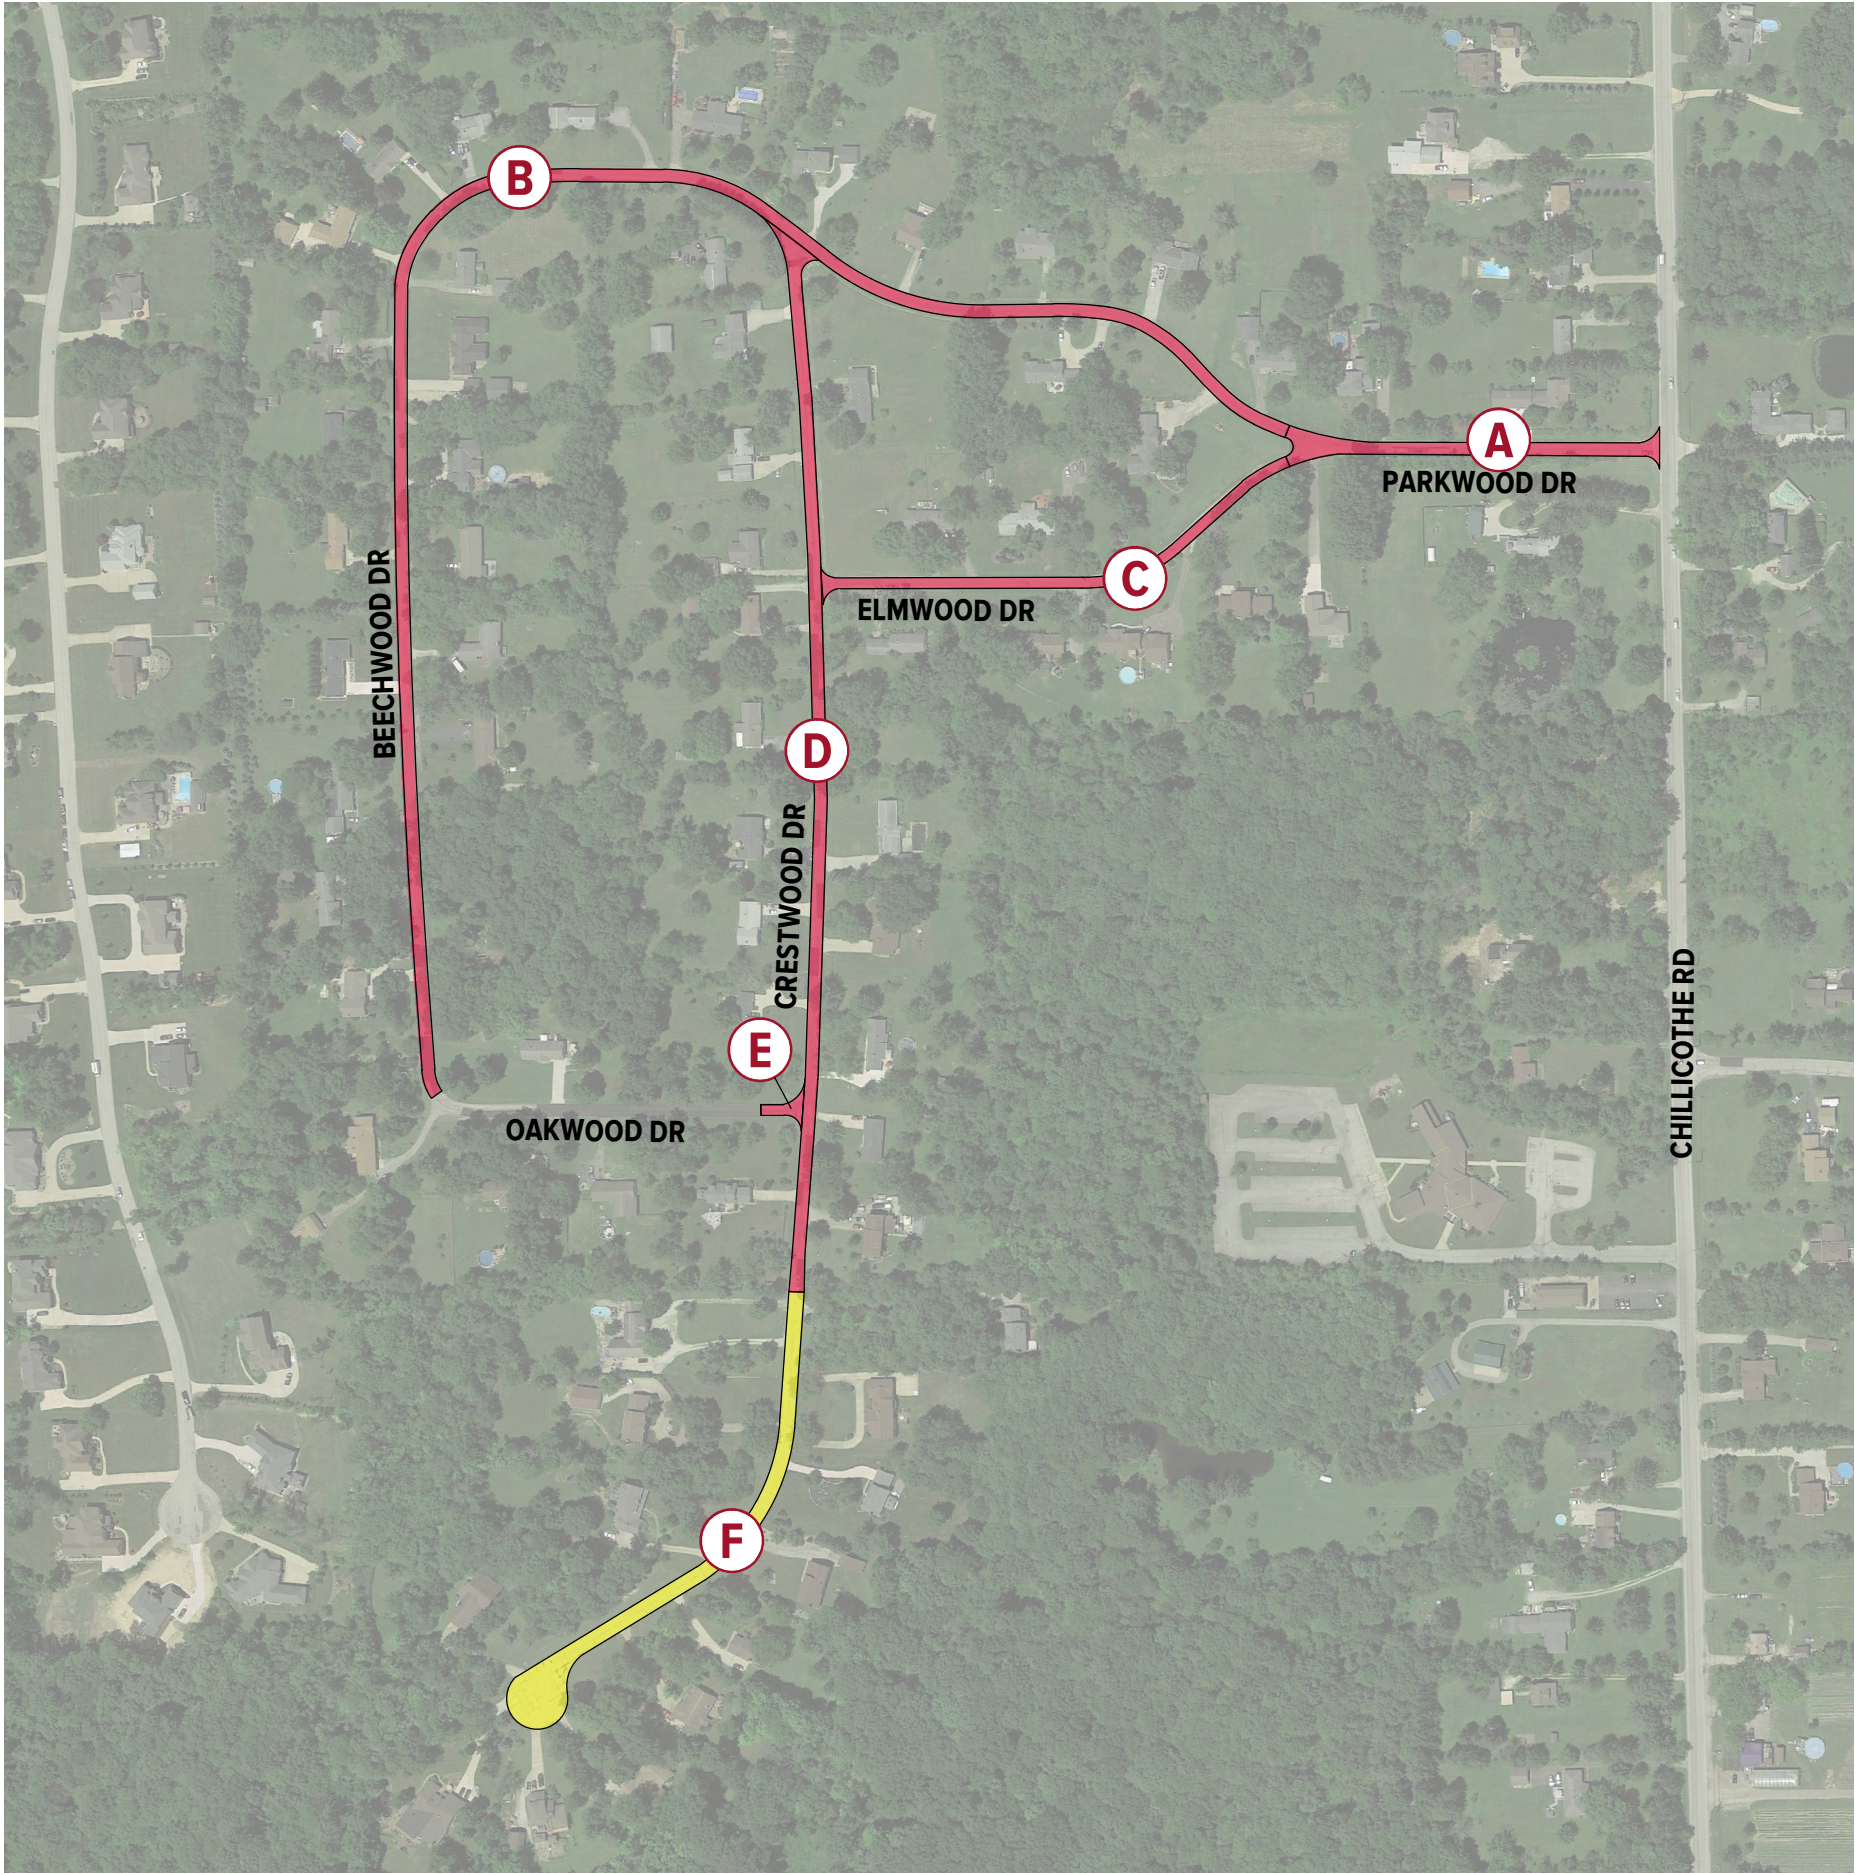
SECTION #	PAVEMENT TYPE	AREA (SQ. FT.)	RATING
A	ASPHALT	13,461	2
B	ASPHALT	57,134	2
C	ASPHALT	13,684	2
D	ASPHALT	34,169	2
E	ASPHALT	1,541	2
F	CONCRETE	26,305	4
TOTAL	ASPHALT	143,105

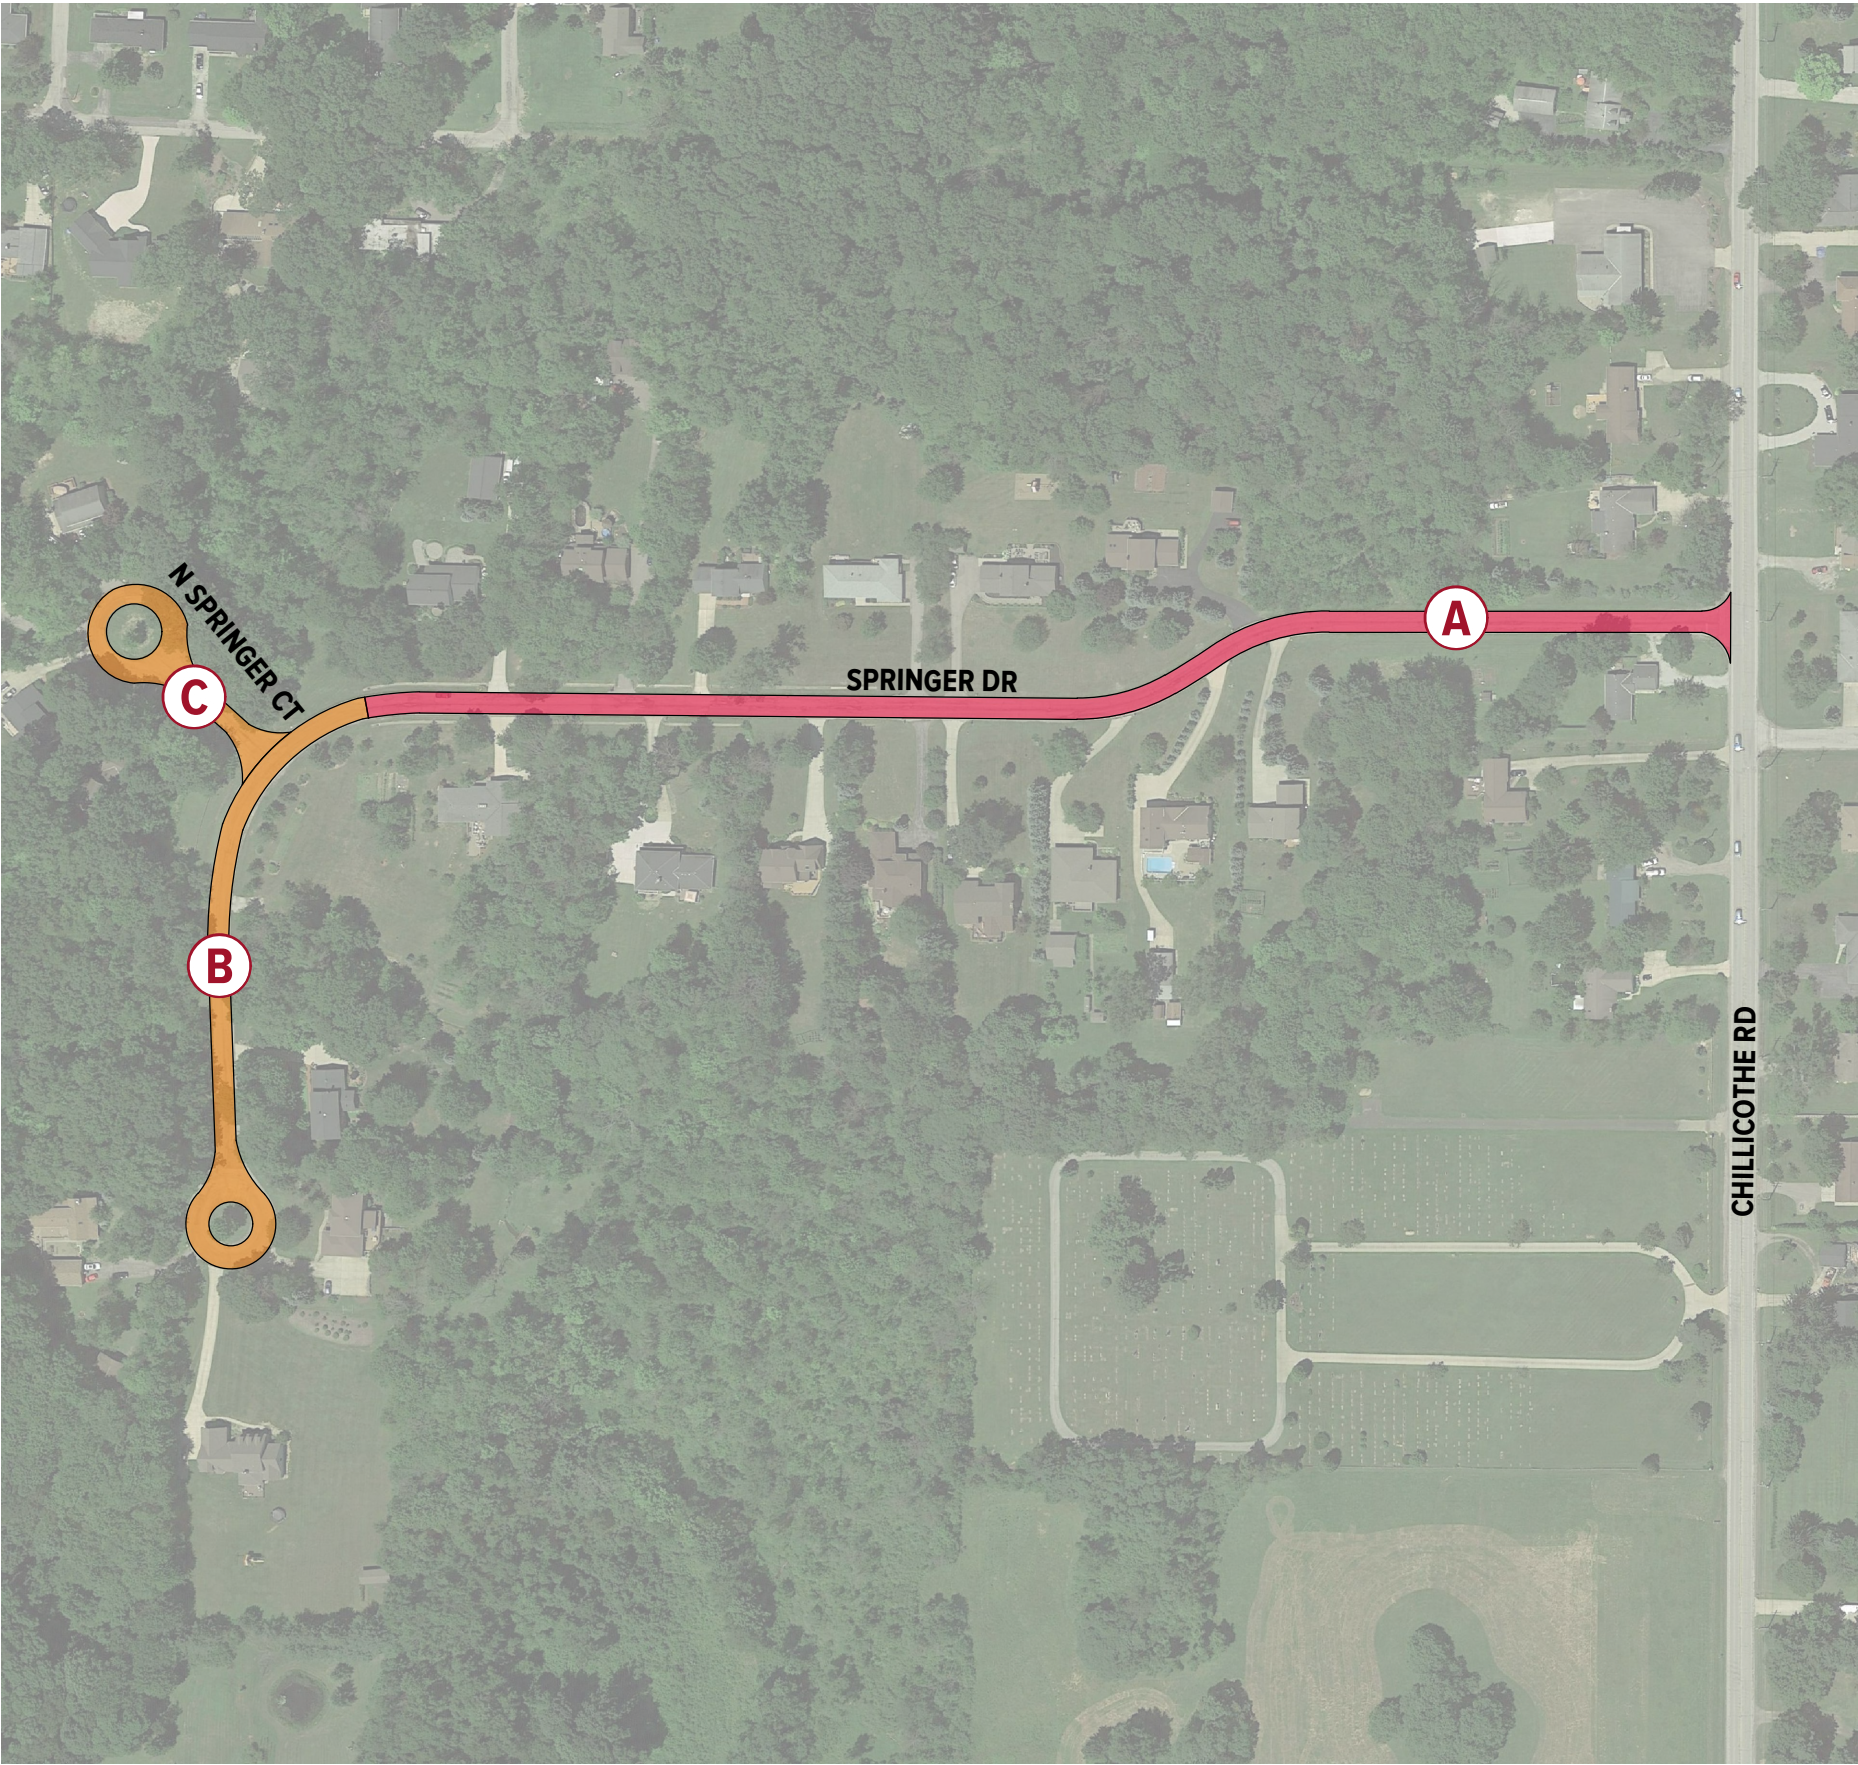
SECTION #	PAVEMENT TYPE	AREA (SQ. FT.)	RATING
A	ASPHALT	32,135	2
B	ASPHALT	18,093	3
C	ASPHALT	9,792	3
TOTAL	ASPHALT	64,340

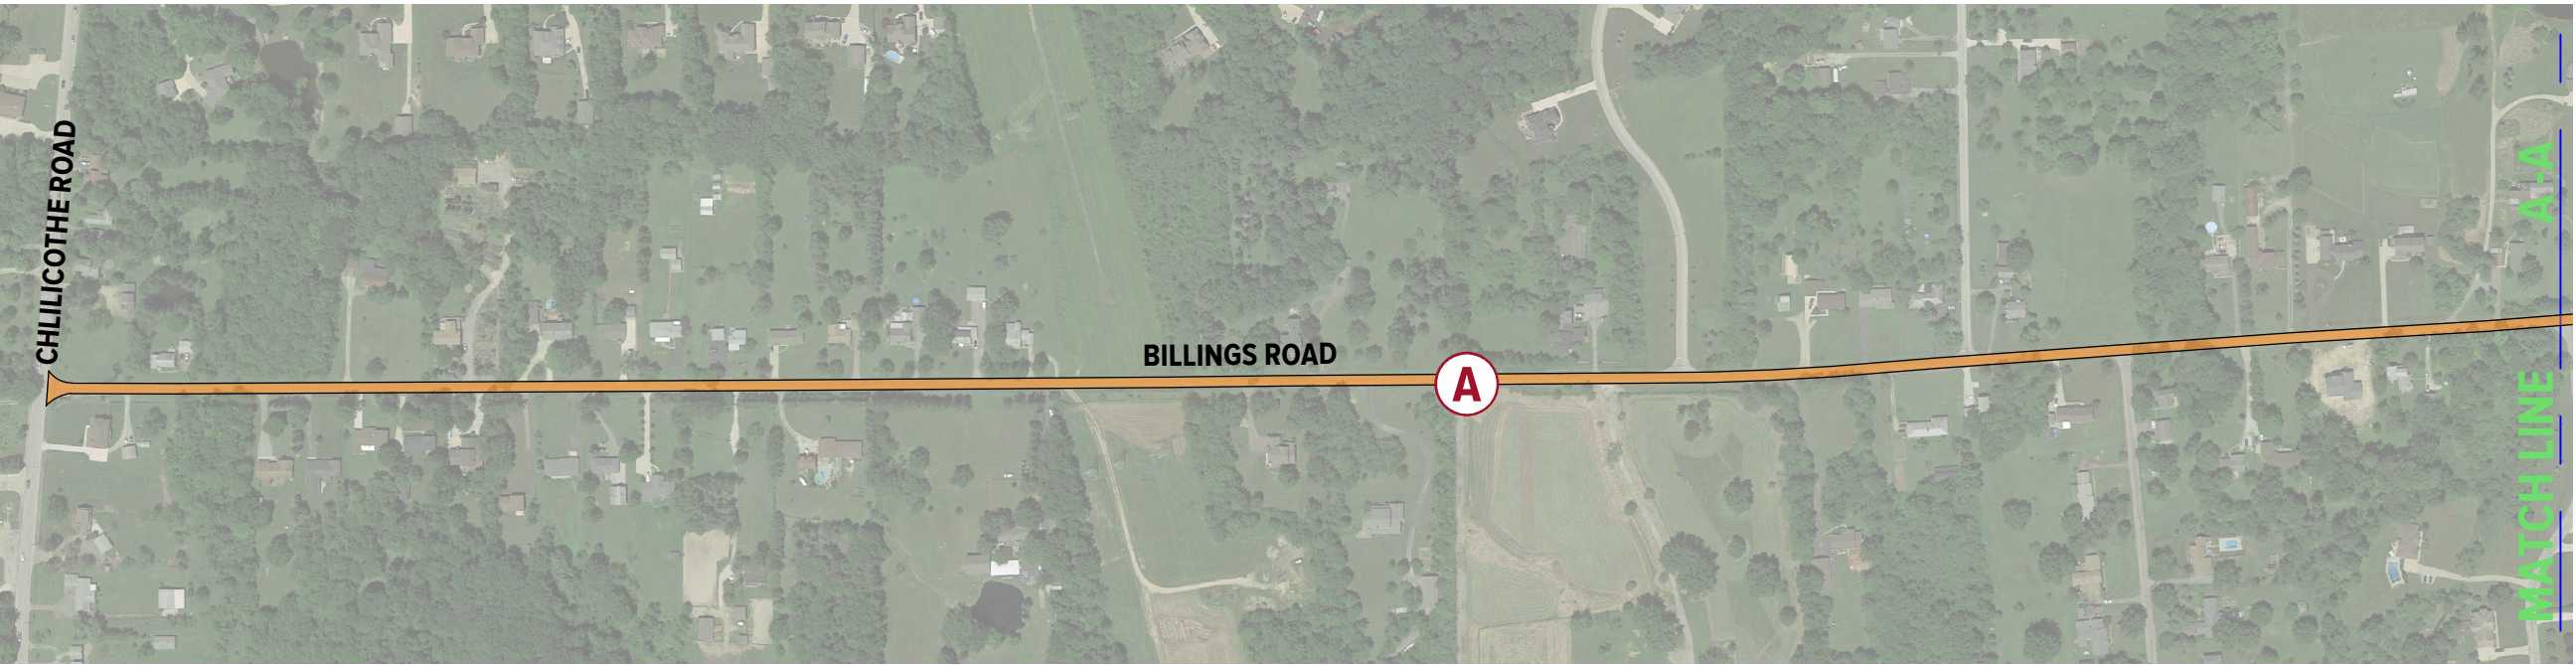
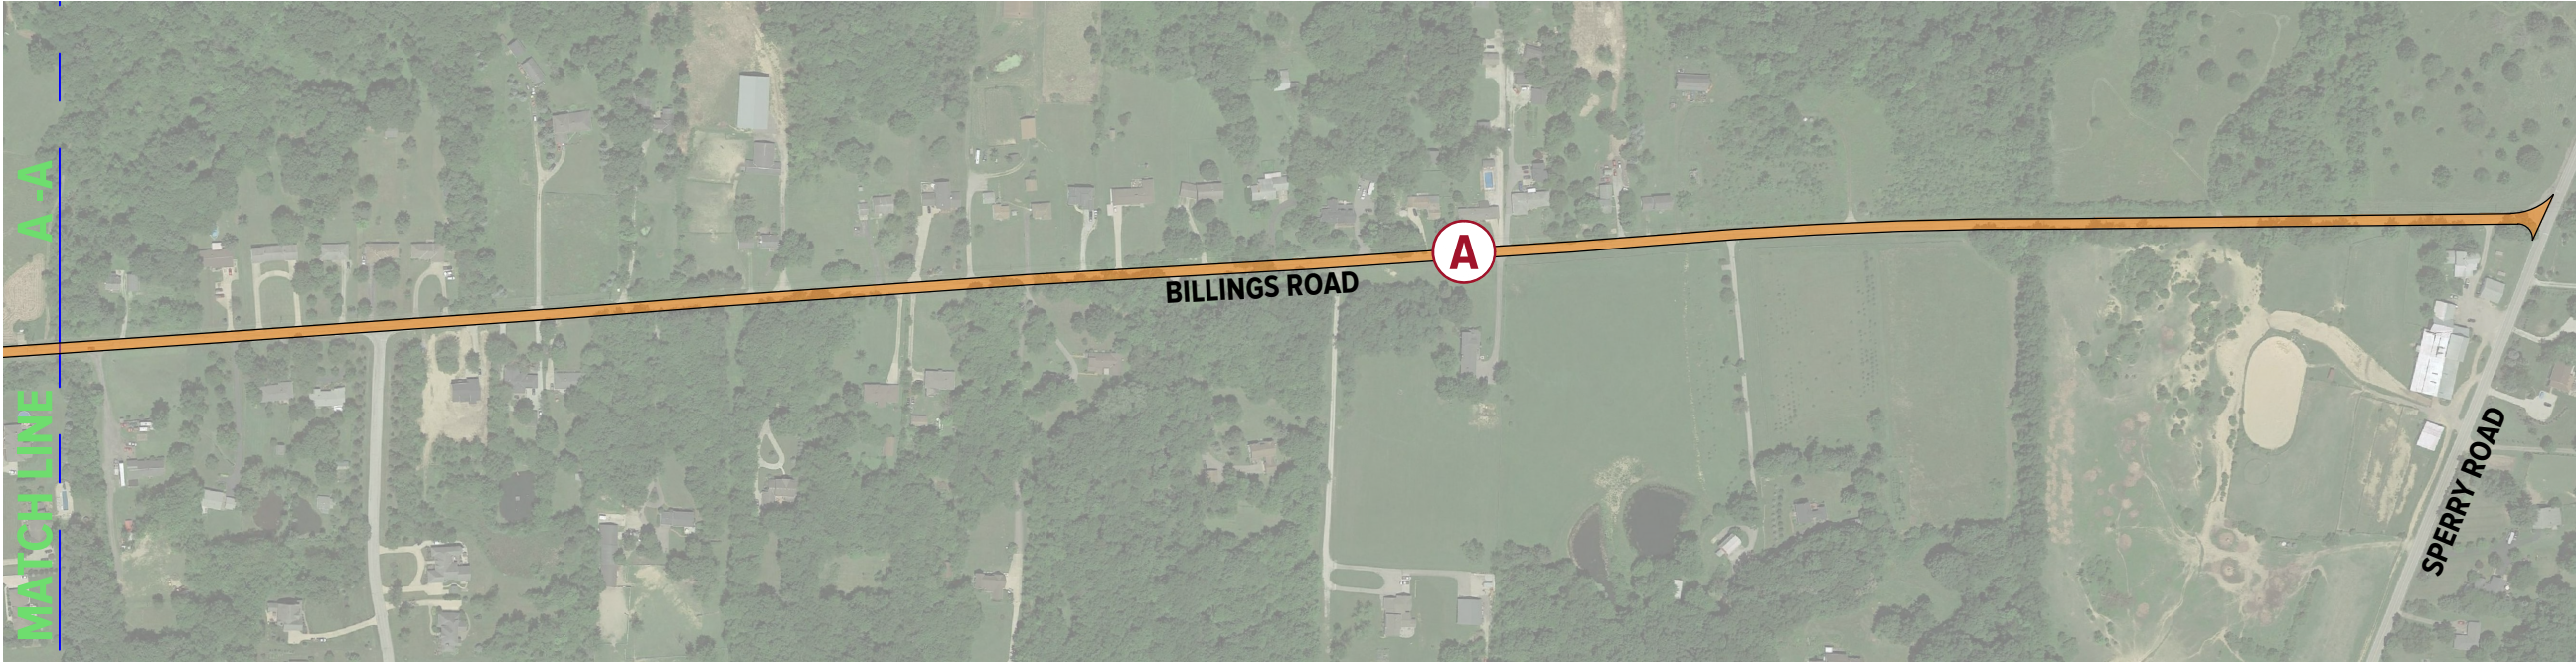
SECTION #	PAVEMENT TYPE	AREA (SQ. FT.)	RATING
A	ASPHALT	238,140	3
TOTAL	ASPHALT	238,140

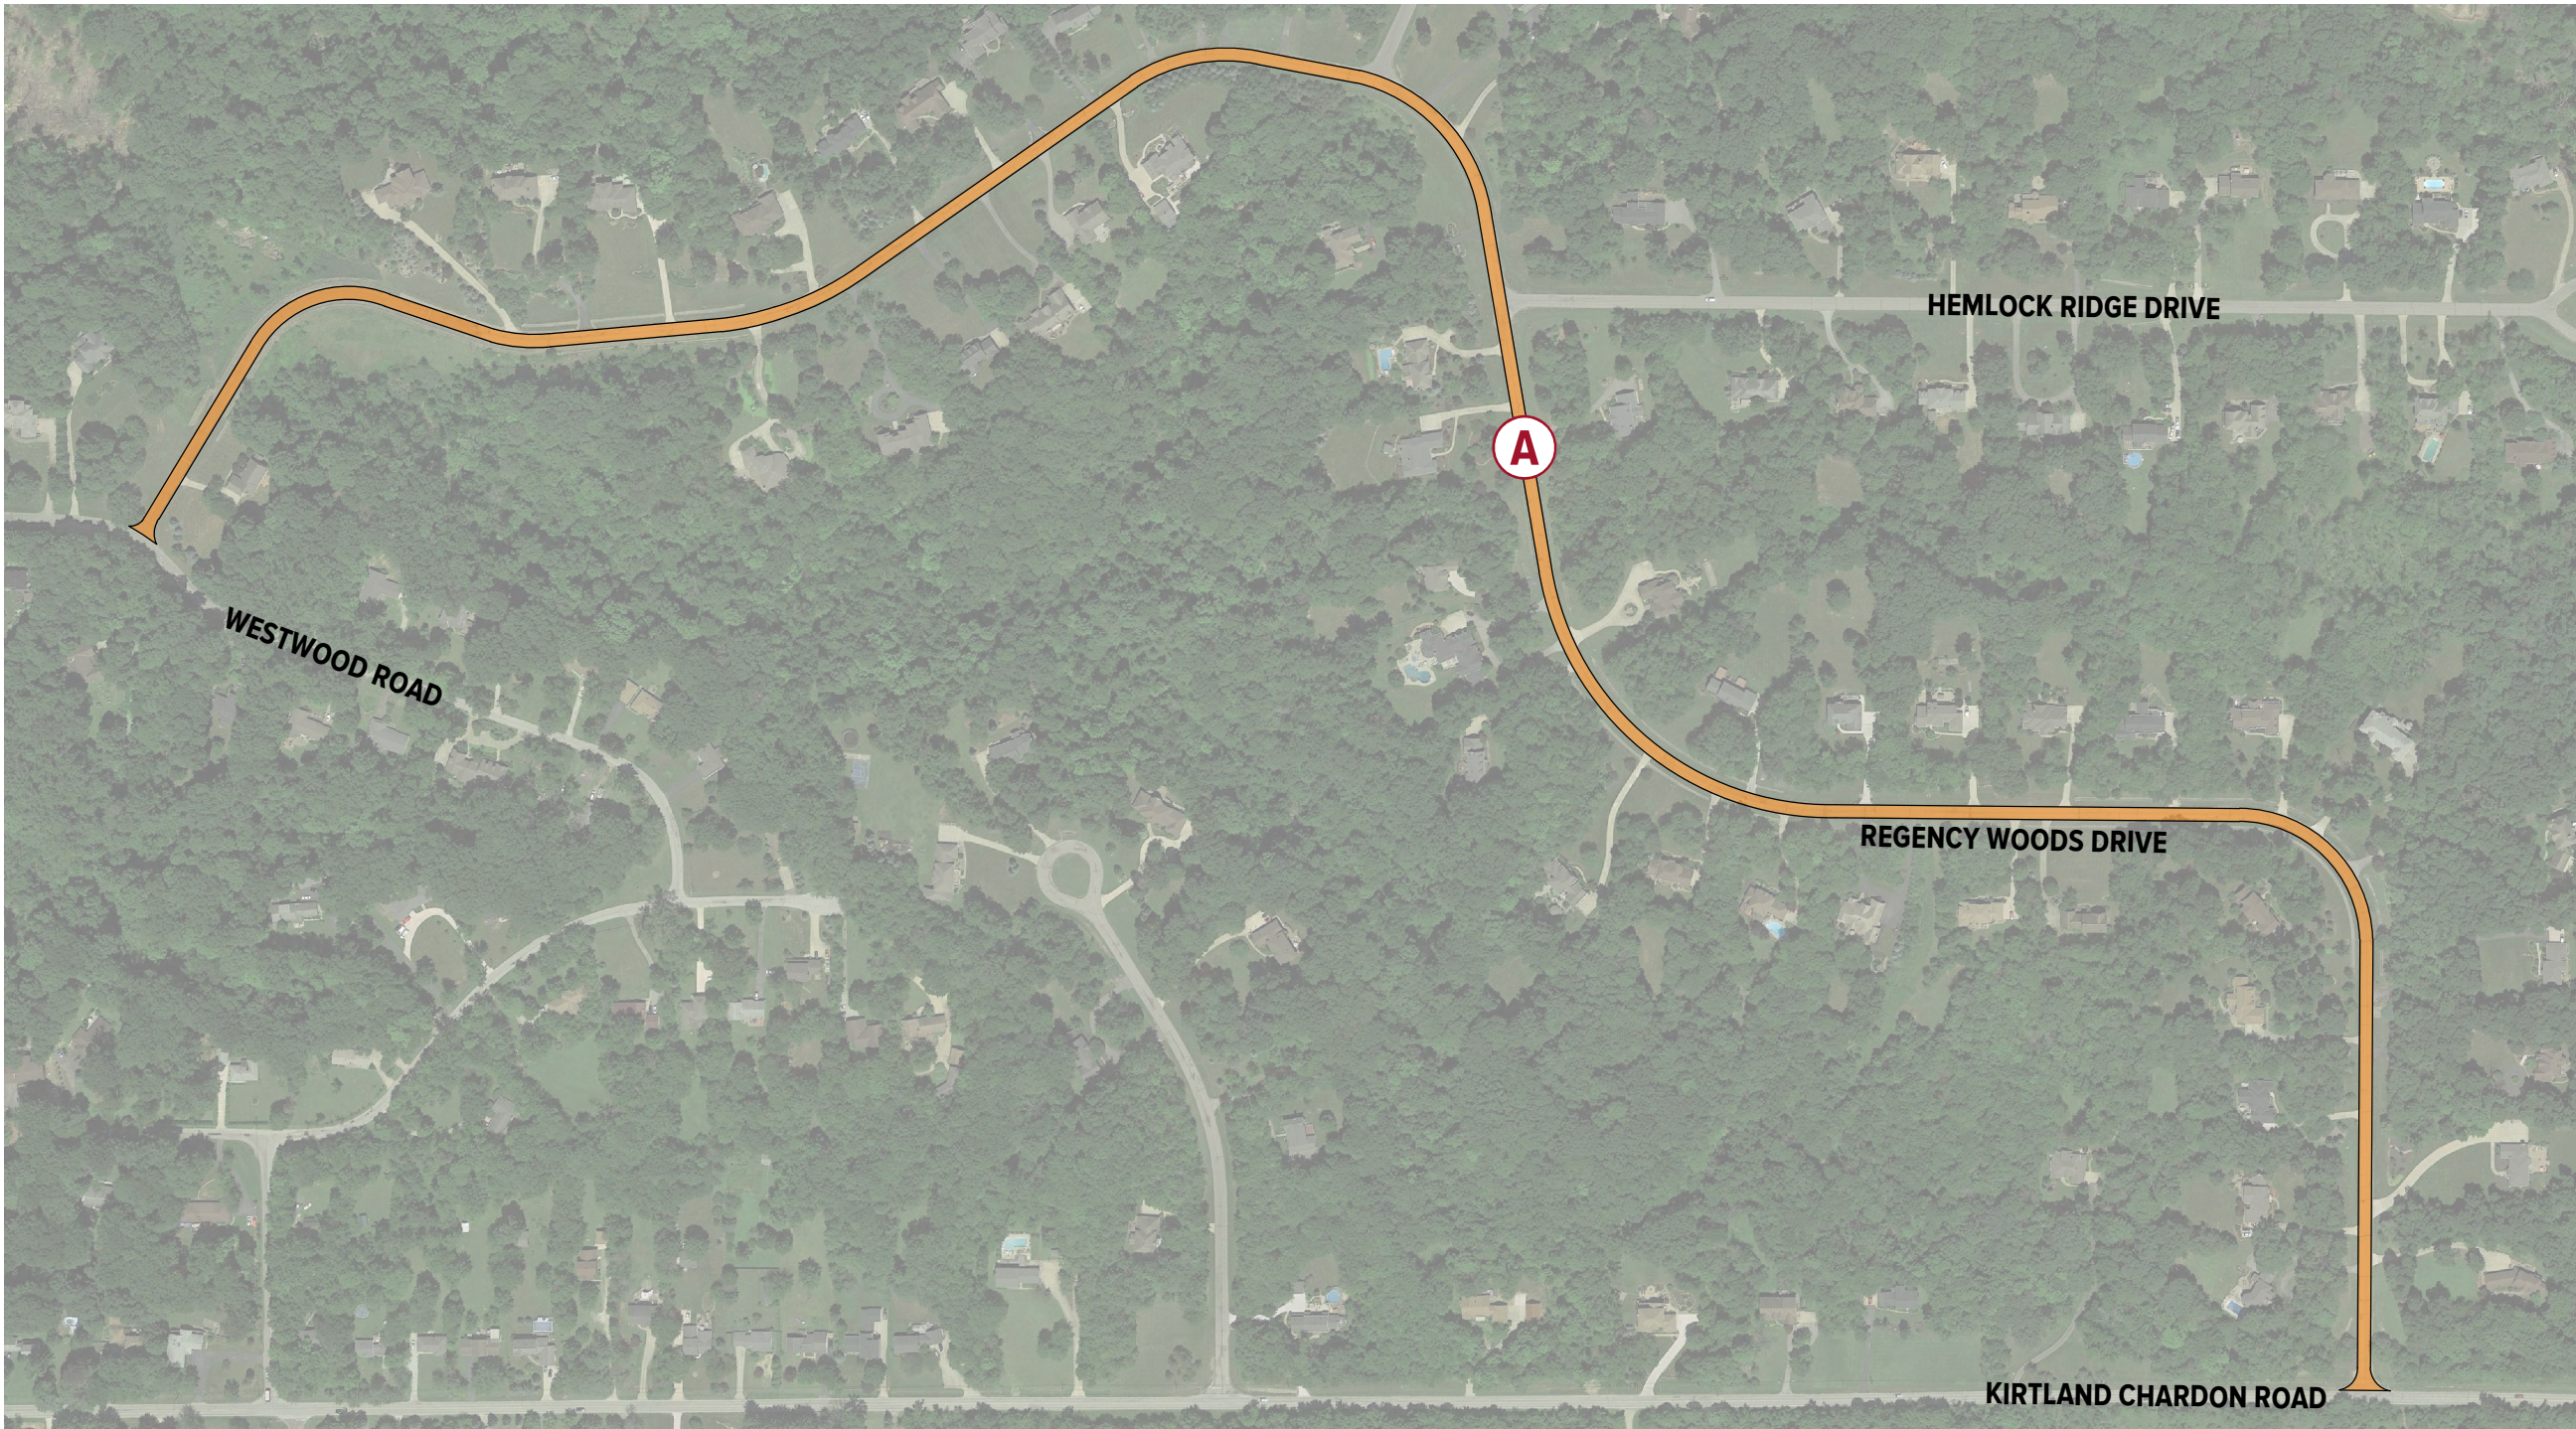
SECTION #	PAVEMENT TYPE	AREA (SQ. FT.)	RATING
A	ASPHALT	152,922	3
TOTAL	ASPHALT	152,922

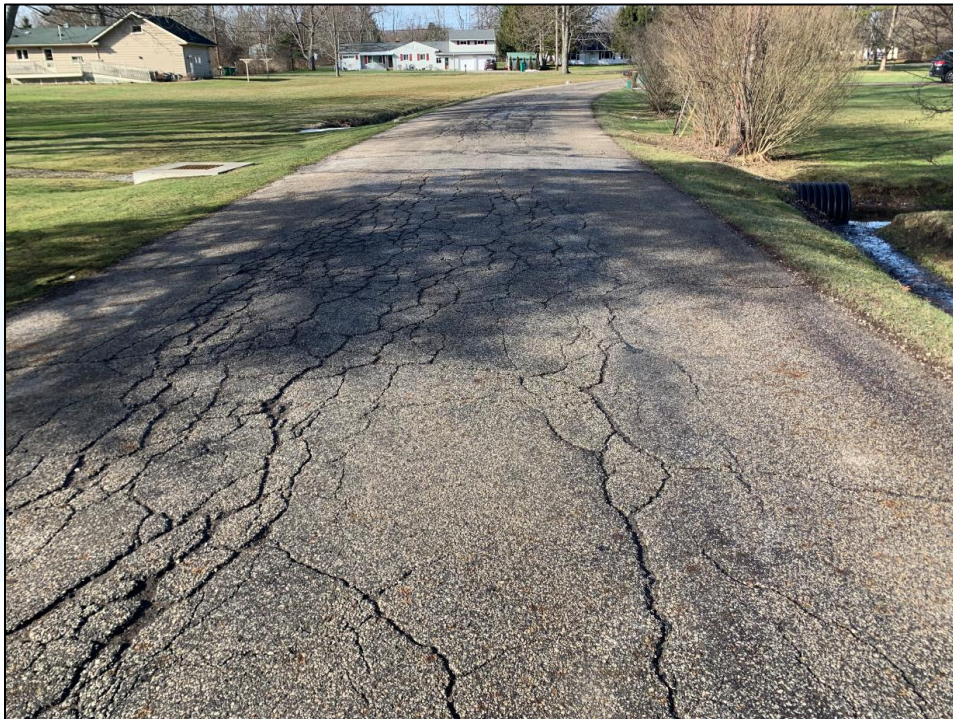
PHOTO NO. 6: Beechwood Drive – Facing Northwest near Address 8121 – Stormwater Outlet to the North

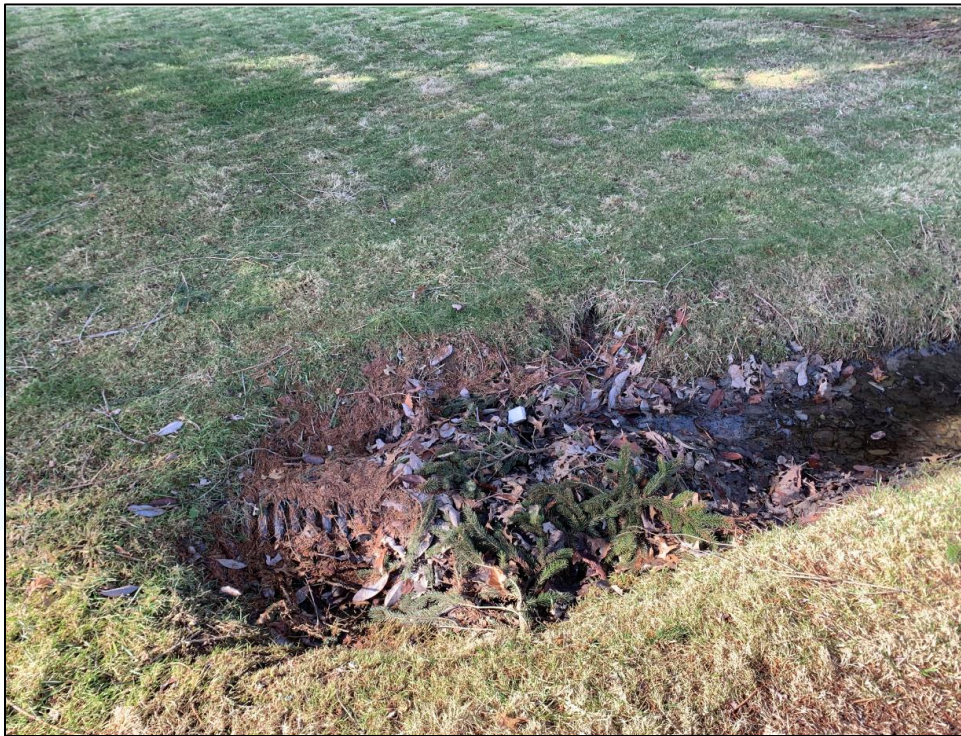
PHOTO NO. 8: Beechwood Drive – Drainage Swale with Plant Debris

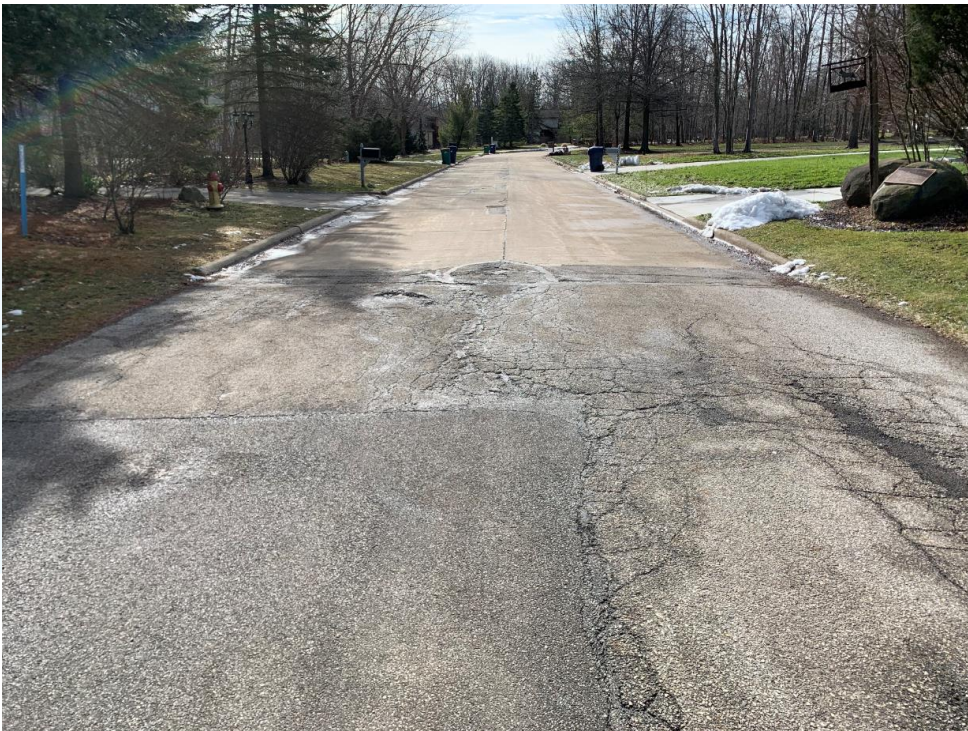
PHOTO NO. 18: Crestwood Drive, Facing South near Address 10870, Transition from Asphalt to Concrete Surface

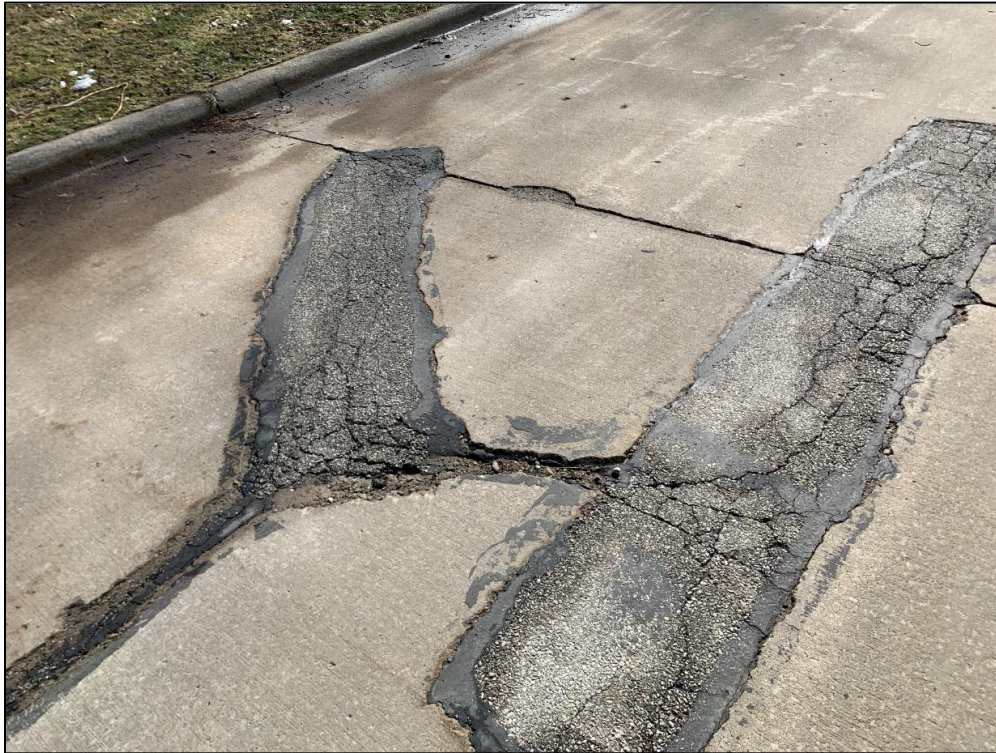
PHOTO NO. 19: Crestwood Drive, Crack and Joint Repair

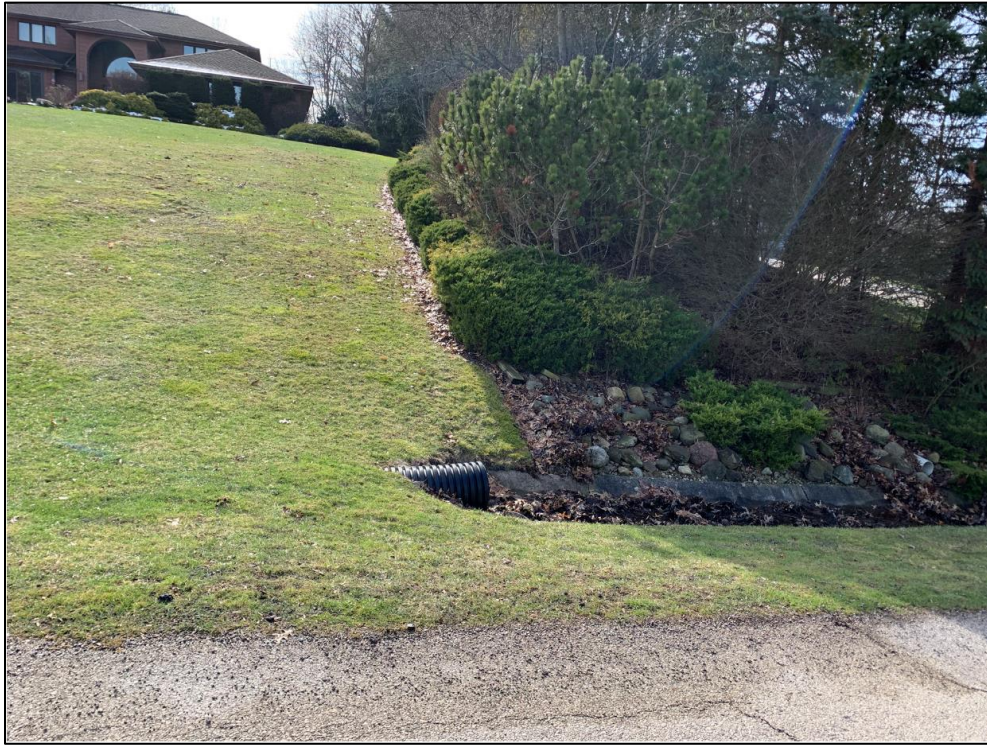
PHOTO NO. 31: Springer Drive, Facing South near Address 8130, Concrete Swale with Leaf Litter
